**PRELIMINARY ASSESSMENT/VISUAL SITE INSPECTION REPORT  
FOR  
AUBREY MANUFACTURING INC.  
UNION, ILLINOIS  
EPA I.D. NO. ILD005238159**

APPENDIX A  
Visual Site Inspection Photograph Log

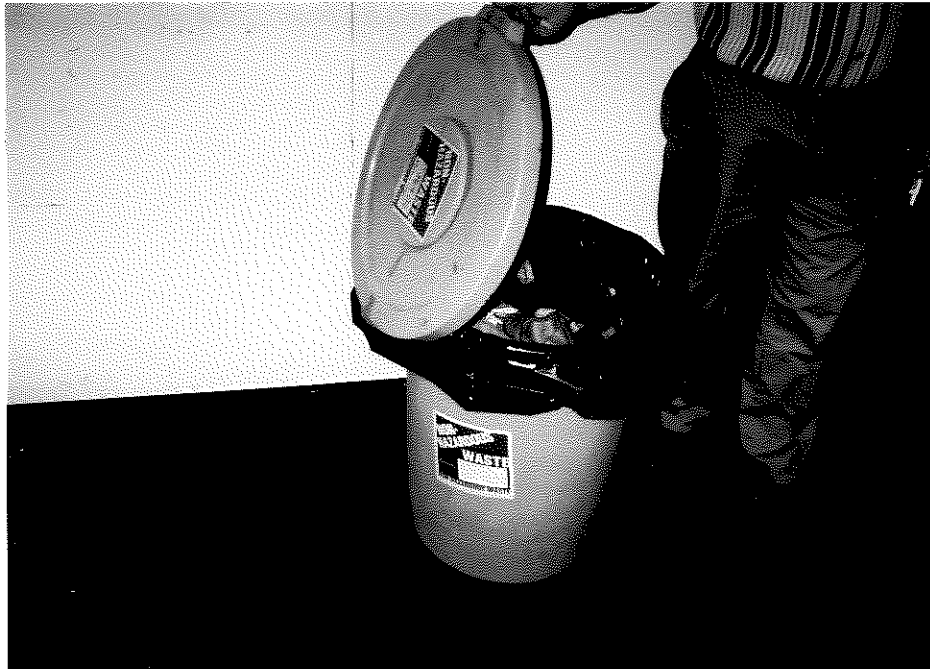
Photo No.: 3  
Date: 11/19/97

Description: View of Non-Hazardous Satellite Accumulation Area in the Welding Room.

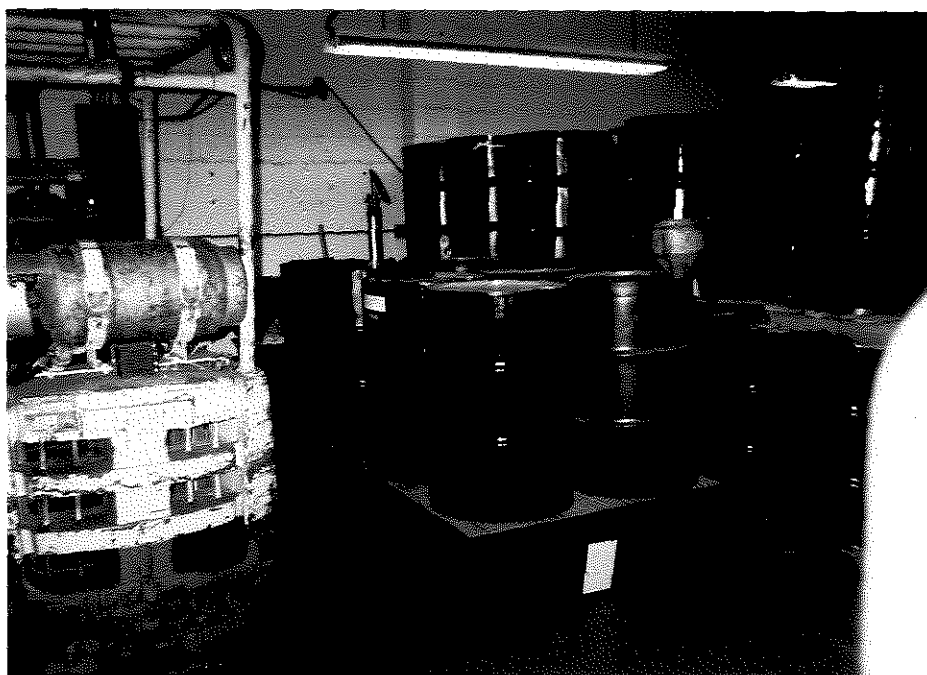
Photo No.: 4  
Date: 11/19/97

Description: View of Waste Oil (SWMU 2). Note, six drums stacked above containment trough contain waste oil drained from the plastic molding/injection machines. The adjacent two-levels of drums contain new, unused oil (bottom row of drums) or are empty (top row of drums).

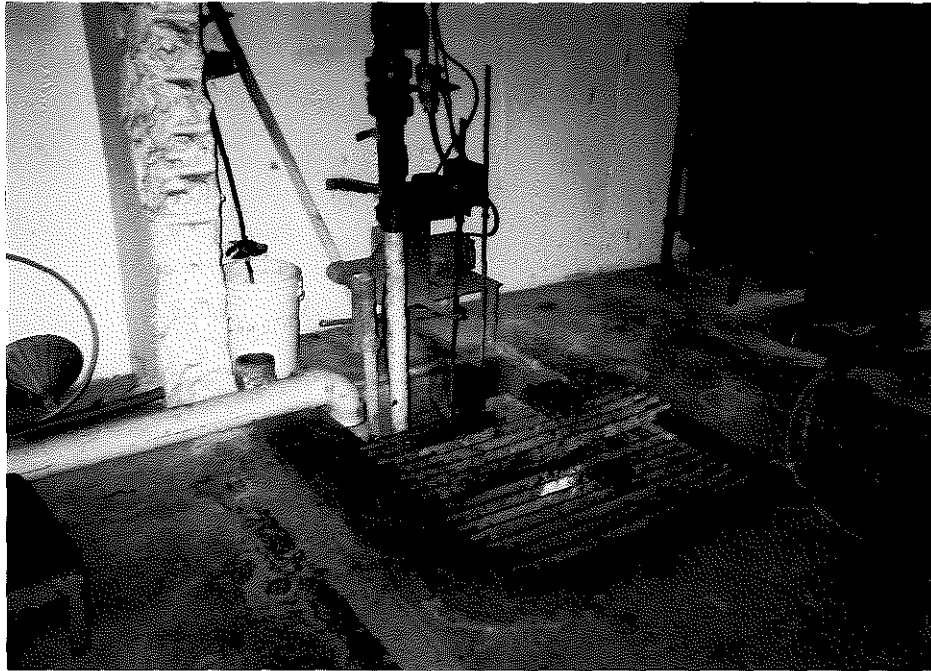
Photo No.: 5  
Date: 11/19/97

Description: View of Collection Sump for Three Stage Washer.

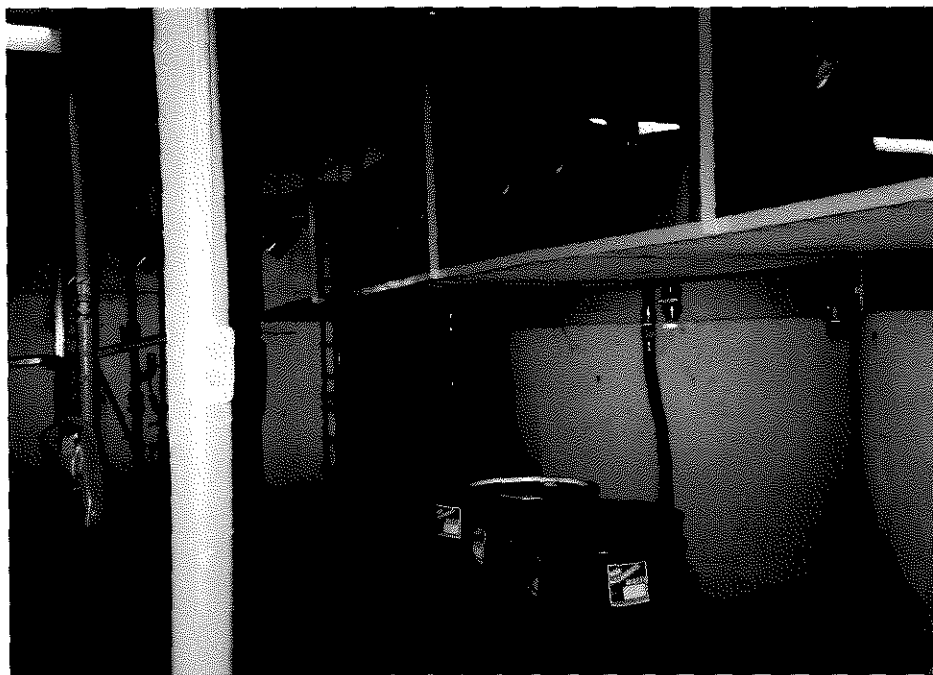
Photo No.: 12  
Time: 1118  
Date: 11/19/97

Description: View of Filter Cake Satellite Accumulation Area. The four drums in this area are full of Filter Cake from the Filter Press in the Water Treatment Room.

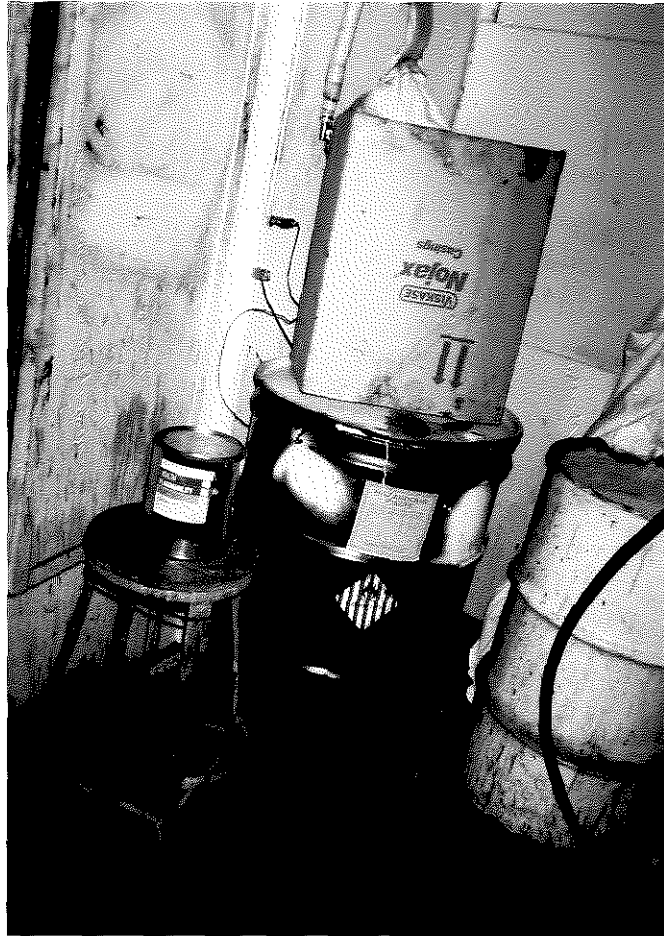
Photo No.: 13  
Date: 11/19/97

Description: View of Hazardous Waste Satellite Accumulation Area (SAA) in Wet Spray Room No. 1 (SWMU 4).

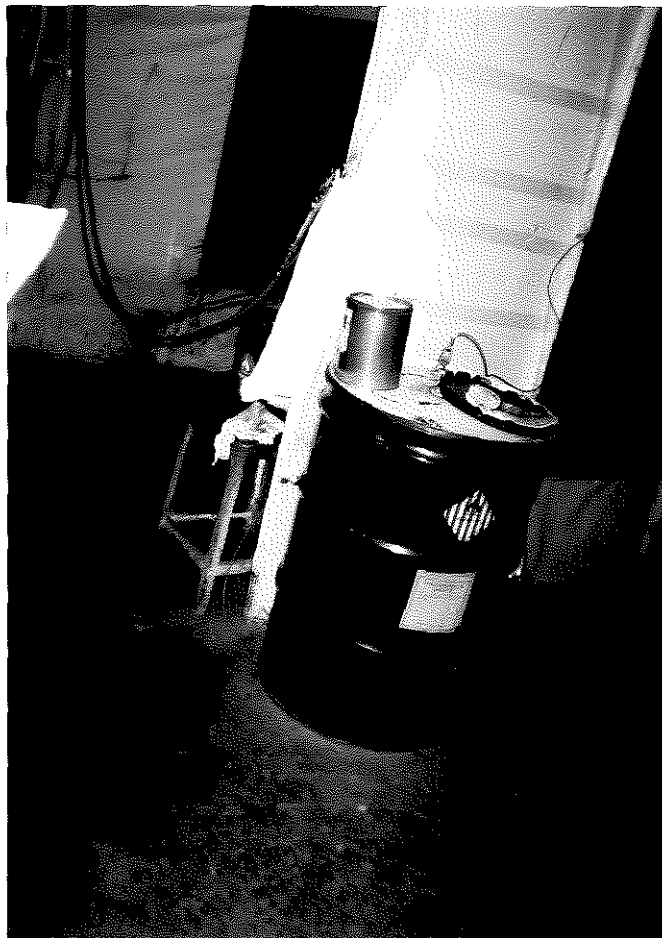
Photo No.: 14  
Date: 11/19/97

**Physical Description:** This unit is currently used as a satellite accumulation area for rags, gloves and wastes generated during the cleaning process of the painting equipment. This unit consists of one (1) 55-gallon drum.

**History of Releases:** No releases were identified in IEPA file materials or during the VSI. According to the facility representatives, no releases have occurred from this unit.

Description: View of Hazardous Waste Satellite Accumulation Area in Wet Spray Paint Room  
No. 2 (SWMU 5).

**Conclusions:** No further action is recommended for this SWMU. No observed releases were identified during the PA/VSI. Additionally, this SWMU exhibits containment via the sealed concrete beneath the drum. Facility personnel indicated that the floor is resealed once per year.

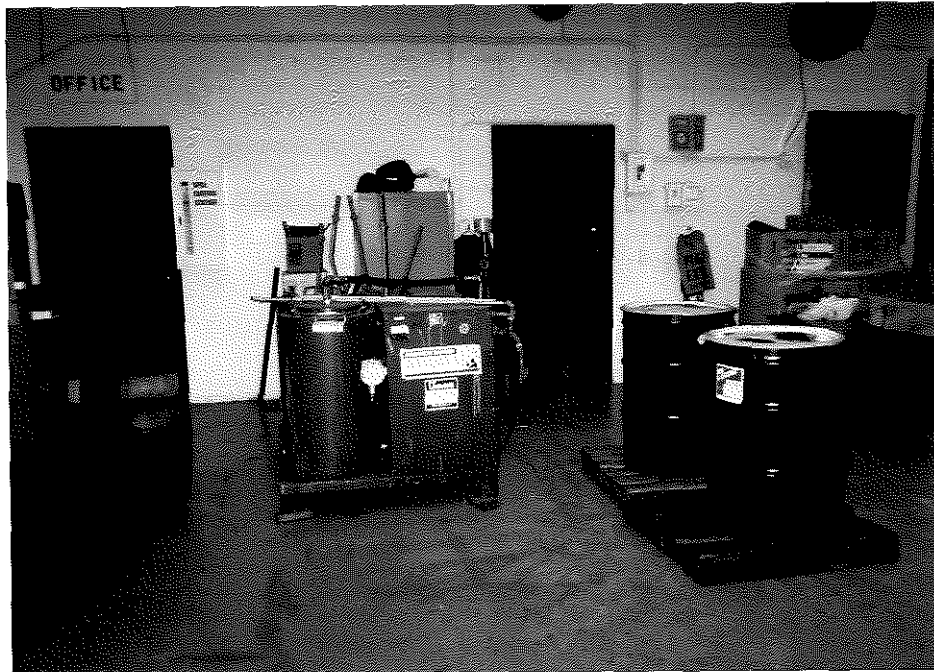
Photo No.: 15  
Date: 11/19/97

Description: View of Hazardous Waste Storage Area (SWMU 6) where drums of both hazardous and non-hazardous wastes are staged before shipment off site. At the time of the VSI, only non-hazardous wastes were in the storage area. Note the dismantled still in the left of the photograph. The still was formerly in the Paint Kitchen when it was operational.

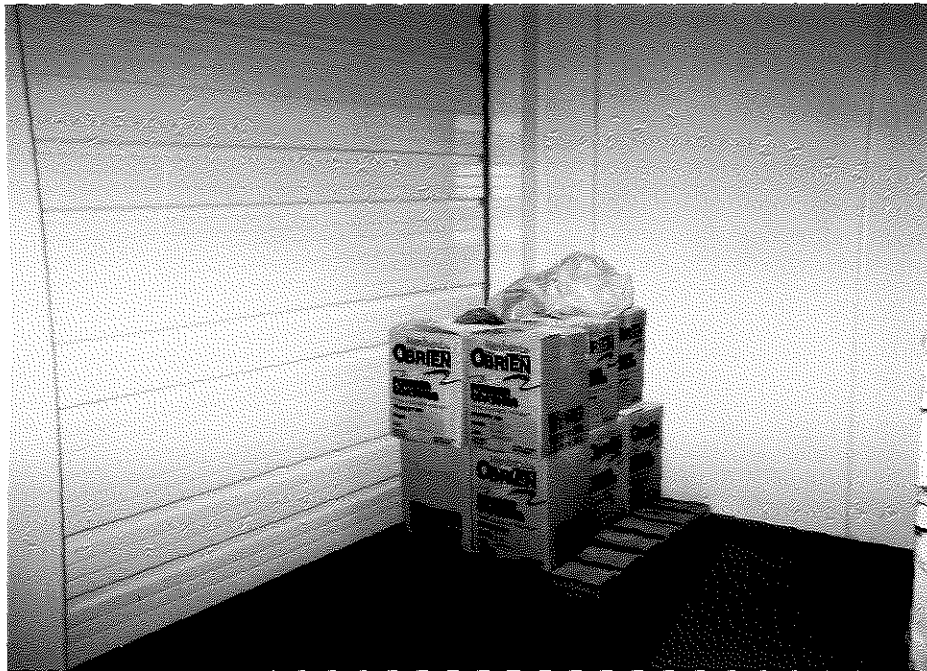
Photo No.: 19  
Date: 11/19/97

Description: View of the Dry Paint Room SAA in which Spent Dry Paint Powder is stored.  
Materials are sent to an off site landfill as non-hazardous waste.

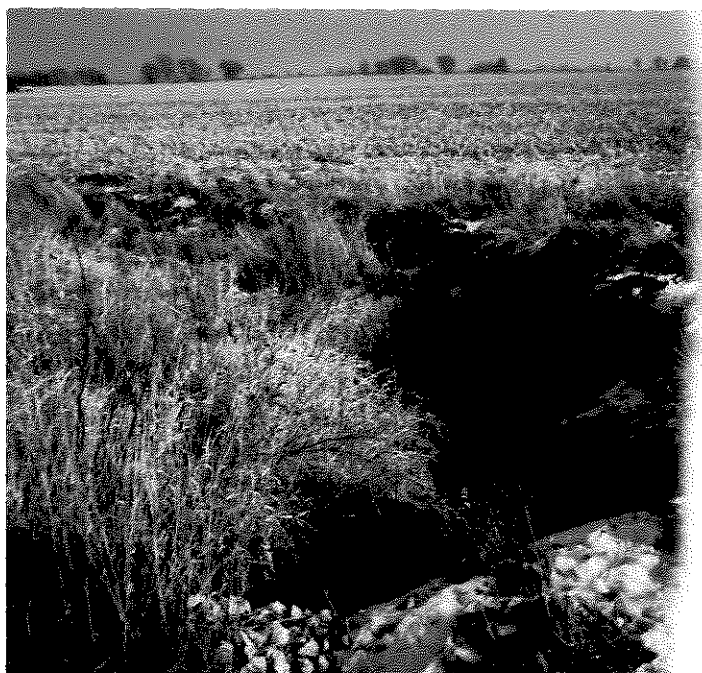
Photo No.: 23  
Date: 11/19/97

Description: View of intermittent creek across Union Road. The facility's NPDES outfall discharges filtered water from the Water Treatment System and non-contact cooling water from the facility to this creek.
